Manhole Inspection Summary

Manhole # S43GG_012MH

Insp Date: **9/2/09 10:58 AM**

Location Address: **1406 BROADWAY (SIDE /REAR)** Cross Street: **HOFFMAN ST**

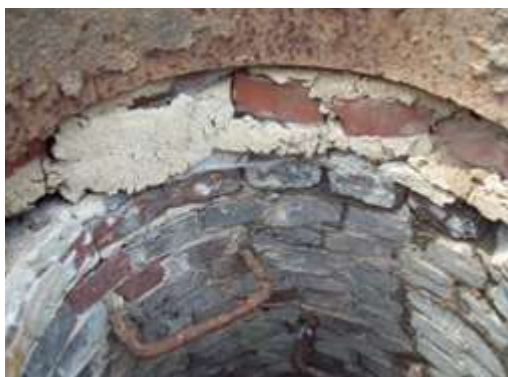
Defect 2

Corbel Material: **Brick** ☐ Parged Type: **Concentric/Eccentric**

Condition: ☐ Sound ☐ Cracked ☐ Root Intrusion ☒ **Loose Brick** ☐ Deteriorated

Infiltration: ☐ None ☐ Joint ☐ Cracks ☒ **Mortar** ☐ Roots ☒ **Wall**

Loose bricks and mortar infiltration at corbel

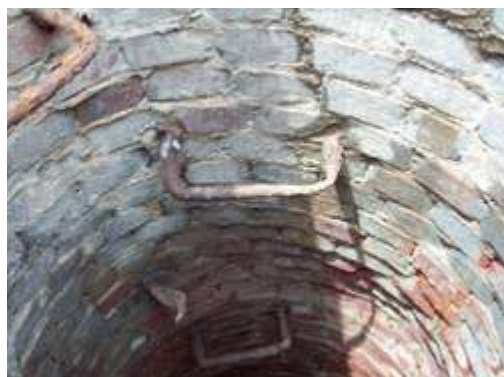
Defect 1

Condition: ☐ Sound ☐ Cracked ☐ Root Intrusion ☒ **Loose Brick** ☐ Deteriorated

Infiltration: ☐ None ☐ Joint ☐ Cracks ☒ **Mortar** ☐ Roots ☐ Wall

Steps Count: **5** Missing: **0** ☒ **Corroded**

Loose bricks and mortar infiltration on barrel, corroded steps

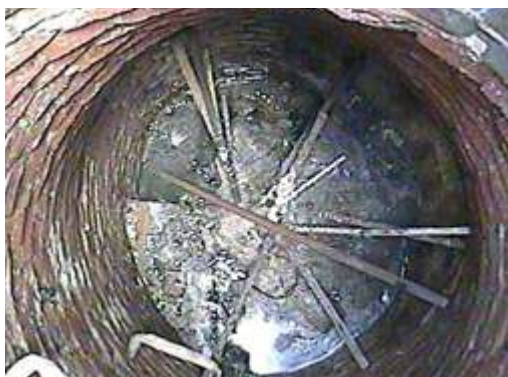
Defect 3

Condition: ☐ Sound ☐ Cracked ☐ Root Intrusion ☐ Deteriorated ☐ Leaks ☒ **Debris**

NOTE AMOUNT OF DEBRIS

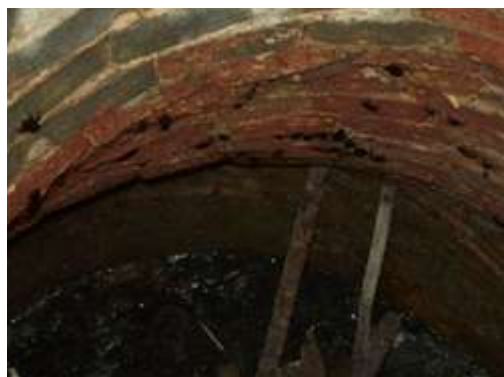
Defect 7

BARREL DETERIATION

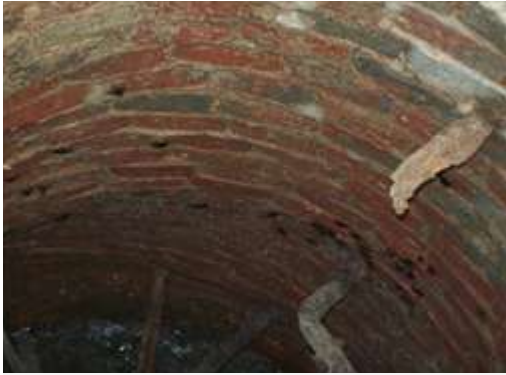
Defect 6

Surcharge ☒ **Evidence Of Surcharge** Depth: **5** (ft.) ☐ Active Surcharge Present

BARREL INFILTRATION, CORRODED STEPS AND EVIDENCE OF ASUR

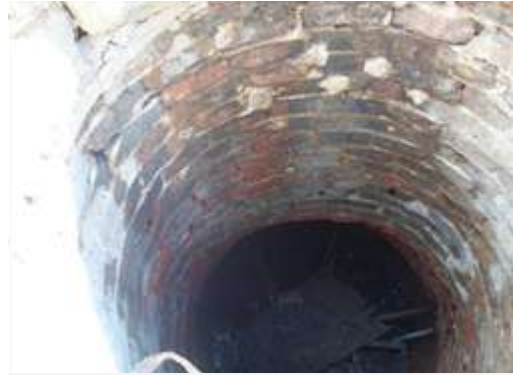
Defect 5

Infiltration: ☐ None ☐ Joint ☐ Cracks ☒ **Mortar** ☐ Roots ☐ Wall

CHIMNEY INFILTRATION

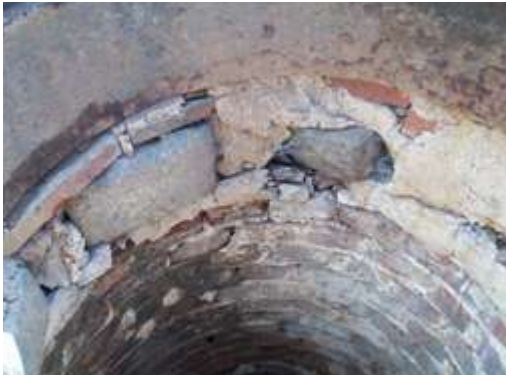
Defect 4

Condition: ☐ Sound ☐ Cracked ☐ Root Intrusion ☐ Loose Brick ☒ **Deteriorated**

CHIMNEY DETERIATION

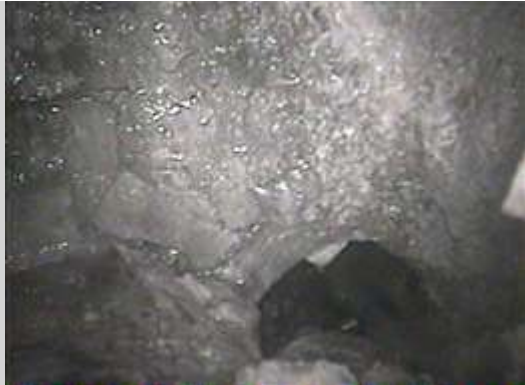
12 O'Clock Outflow

8 in. Circular Gravity Sewer
Pipe Out @ 12 O'Clock

Deposits: ☐ None ☐ Mud ☐ Sludge ☒ **Debris** ☐ Grease

Silt Depth: **0** (in.) Deposits Extent: **Medium**

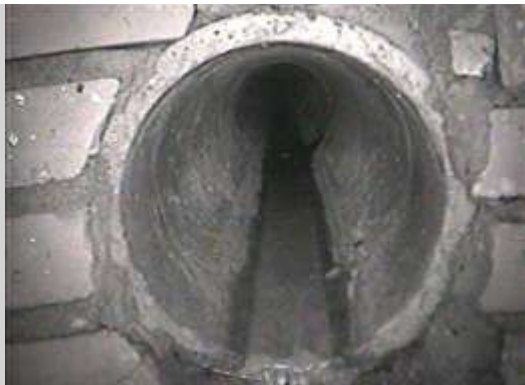
6 O'Clock Inflow

8 in. Circular Gravity Sewer
Pipe In @ 6 O'Clock

Deposits: ☐ None ☐ Mud ☐ Sludge ☒ **Debris** ☐ Grease

Silt Depth: **0** (in.) Deposits Extent: **Medium**
